Village Facilities Plan 2014

Village of Summit

Building Plan & Design Services

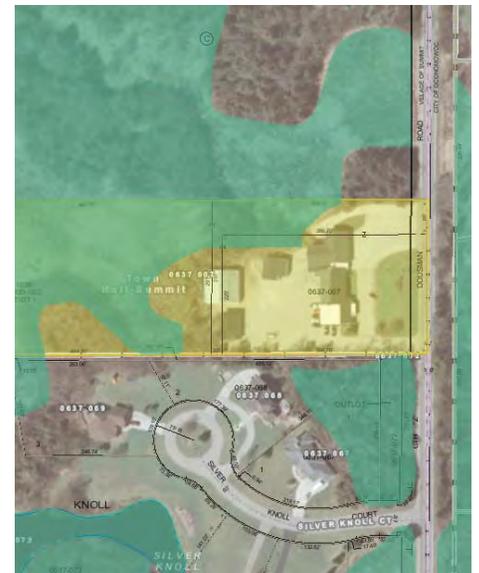
Figure 1.14: Plat of Survey with Wetlands, Water

- Large areas of floodplain, environmental corridors and wetlands are within property limits; typical 50' setback is required and to be confirmed by DNR; Notice of Intent may be required.
- Archaeological structures are known to be located within vicinity of the existing building; archaeological review is recommended prior to the submittal of State Permit Applications.

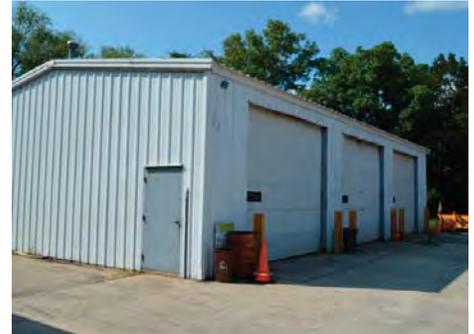
Figure 1.17: DPW Main Garage

- Wall mounted light sconce(s) above each garage door.
- Dated light sconce(s) mounted to the soffits and walls near all municipal building entrances.

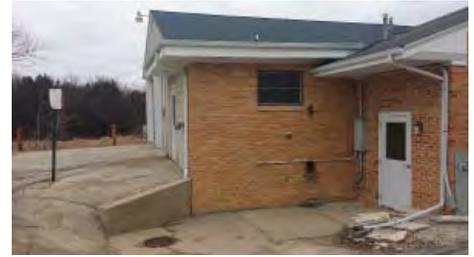
Figure 1.21: West Entrance/Exit, Drainage, Roofs

- *Roof:* The roof is a combination of a series of gable-style roofs and flat roof. Because of its multiple additions, the multiple roof pitches vary from one another and adjoin haphazardly. This attachment complicates the replacement of the roof. There are overhangs above the door and window on the building's south facade, and a larger canopy over the main entrance on the building's east facade.

- *Drainage:* Water flows directly into the wetlands, as there is no existing water remediation or retention pond. Drainage issues are present on site, and the owner has observed dampness and water permeation along the west wall of the main basement recreational room.

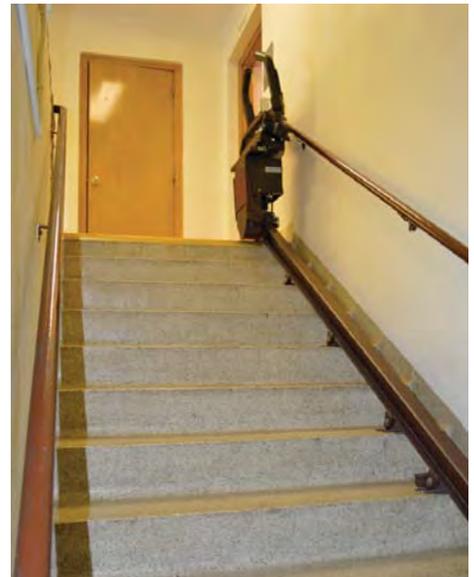
Figure 1.25: Staircase, Foyer to Basement Rec. Room

- Stairs: Beige, vinyl composition, worn on nose of stair treads
- Trim:
 - Lower Level Basement Rec. Room & Bar: Brown rubber base, about 5".
 - Main Basement Rec. Room: Gray rubber base, about 3".

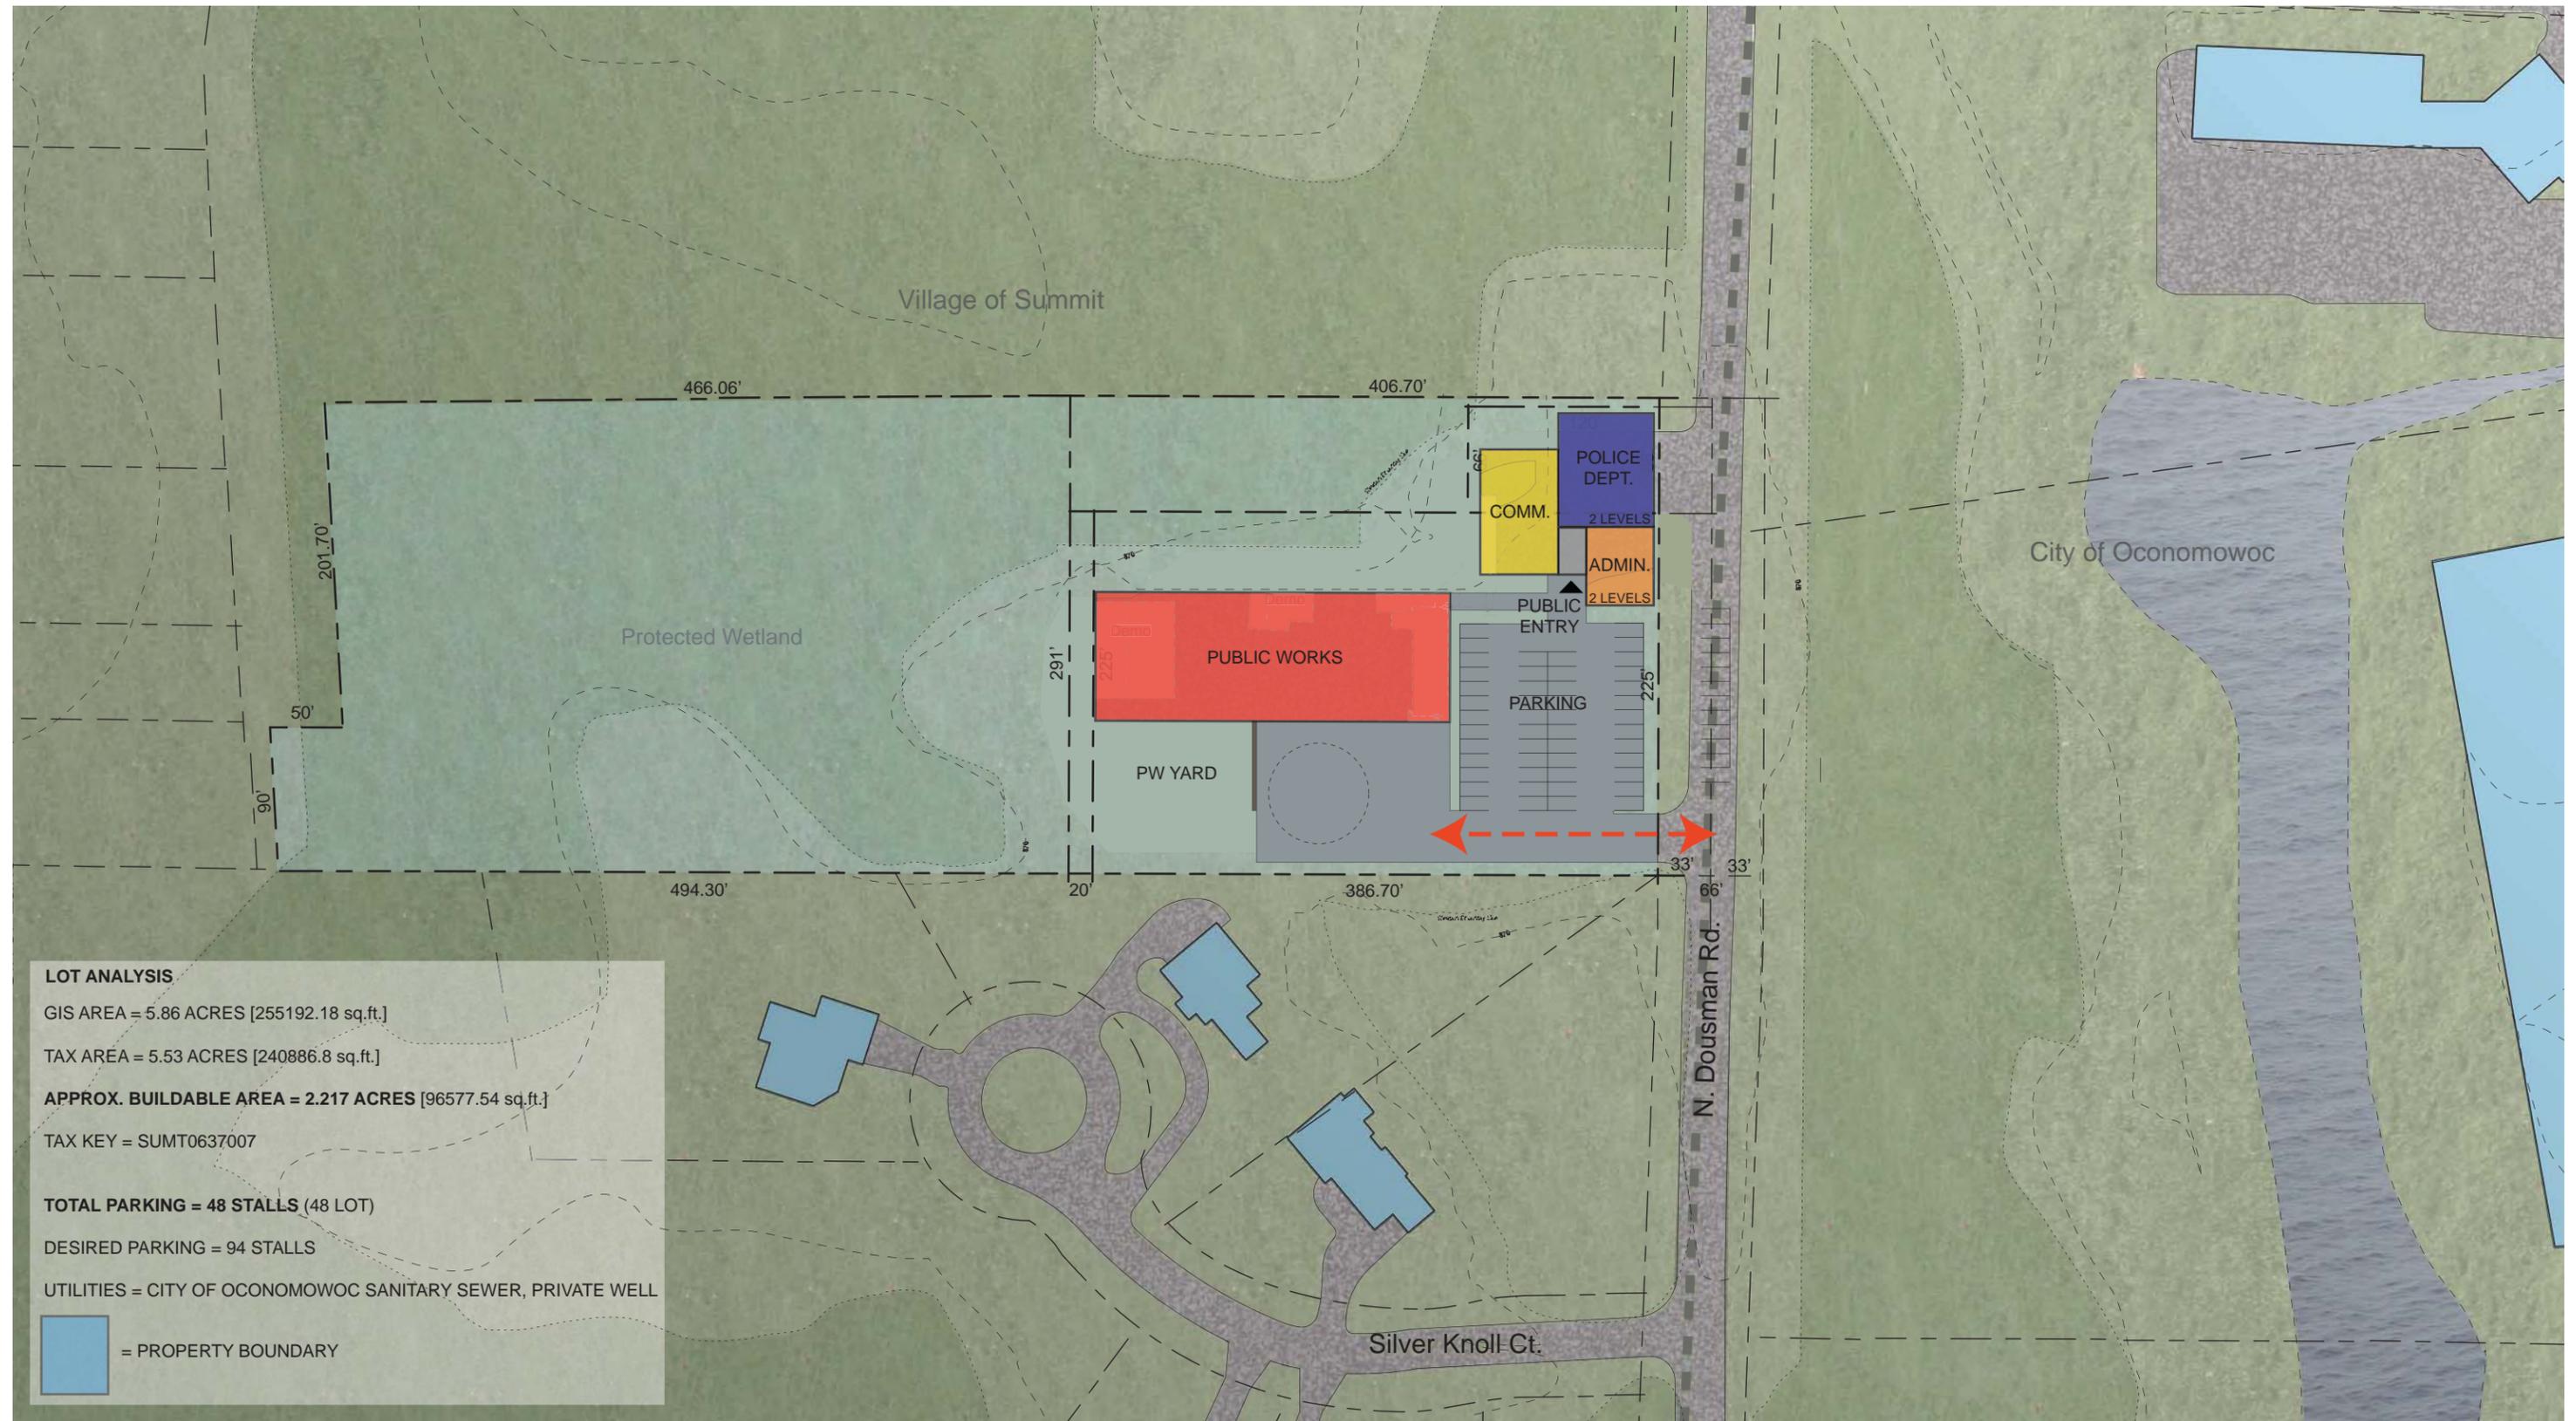
Option 1B:

New Construction - Existing Site | Cost Estimate \$7,132,507 - \$7,883,299

LOT ANALYSIS
 GIS AREA = 5.86 ACRES [255192.18 sq.ft.]
 TAX AREA = 5.53 ACRES [240886.8 sq.ft.]
APPROX. BUILDABLE AREA = 2.217 ACRES [96577.54 sq.ft.]
 TAX KEY = SUMT0637007

TOTAL PARKING = 48 STALLS (48 LOT)
 DESIRED PARKING = 94 STALLS

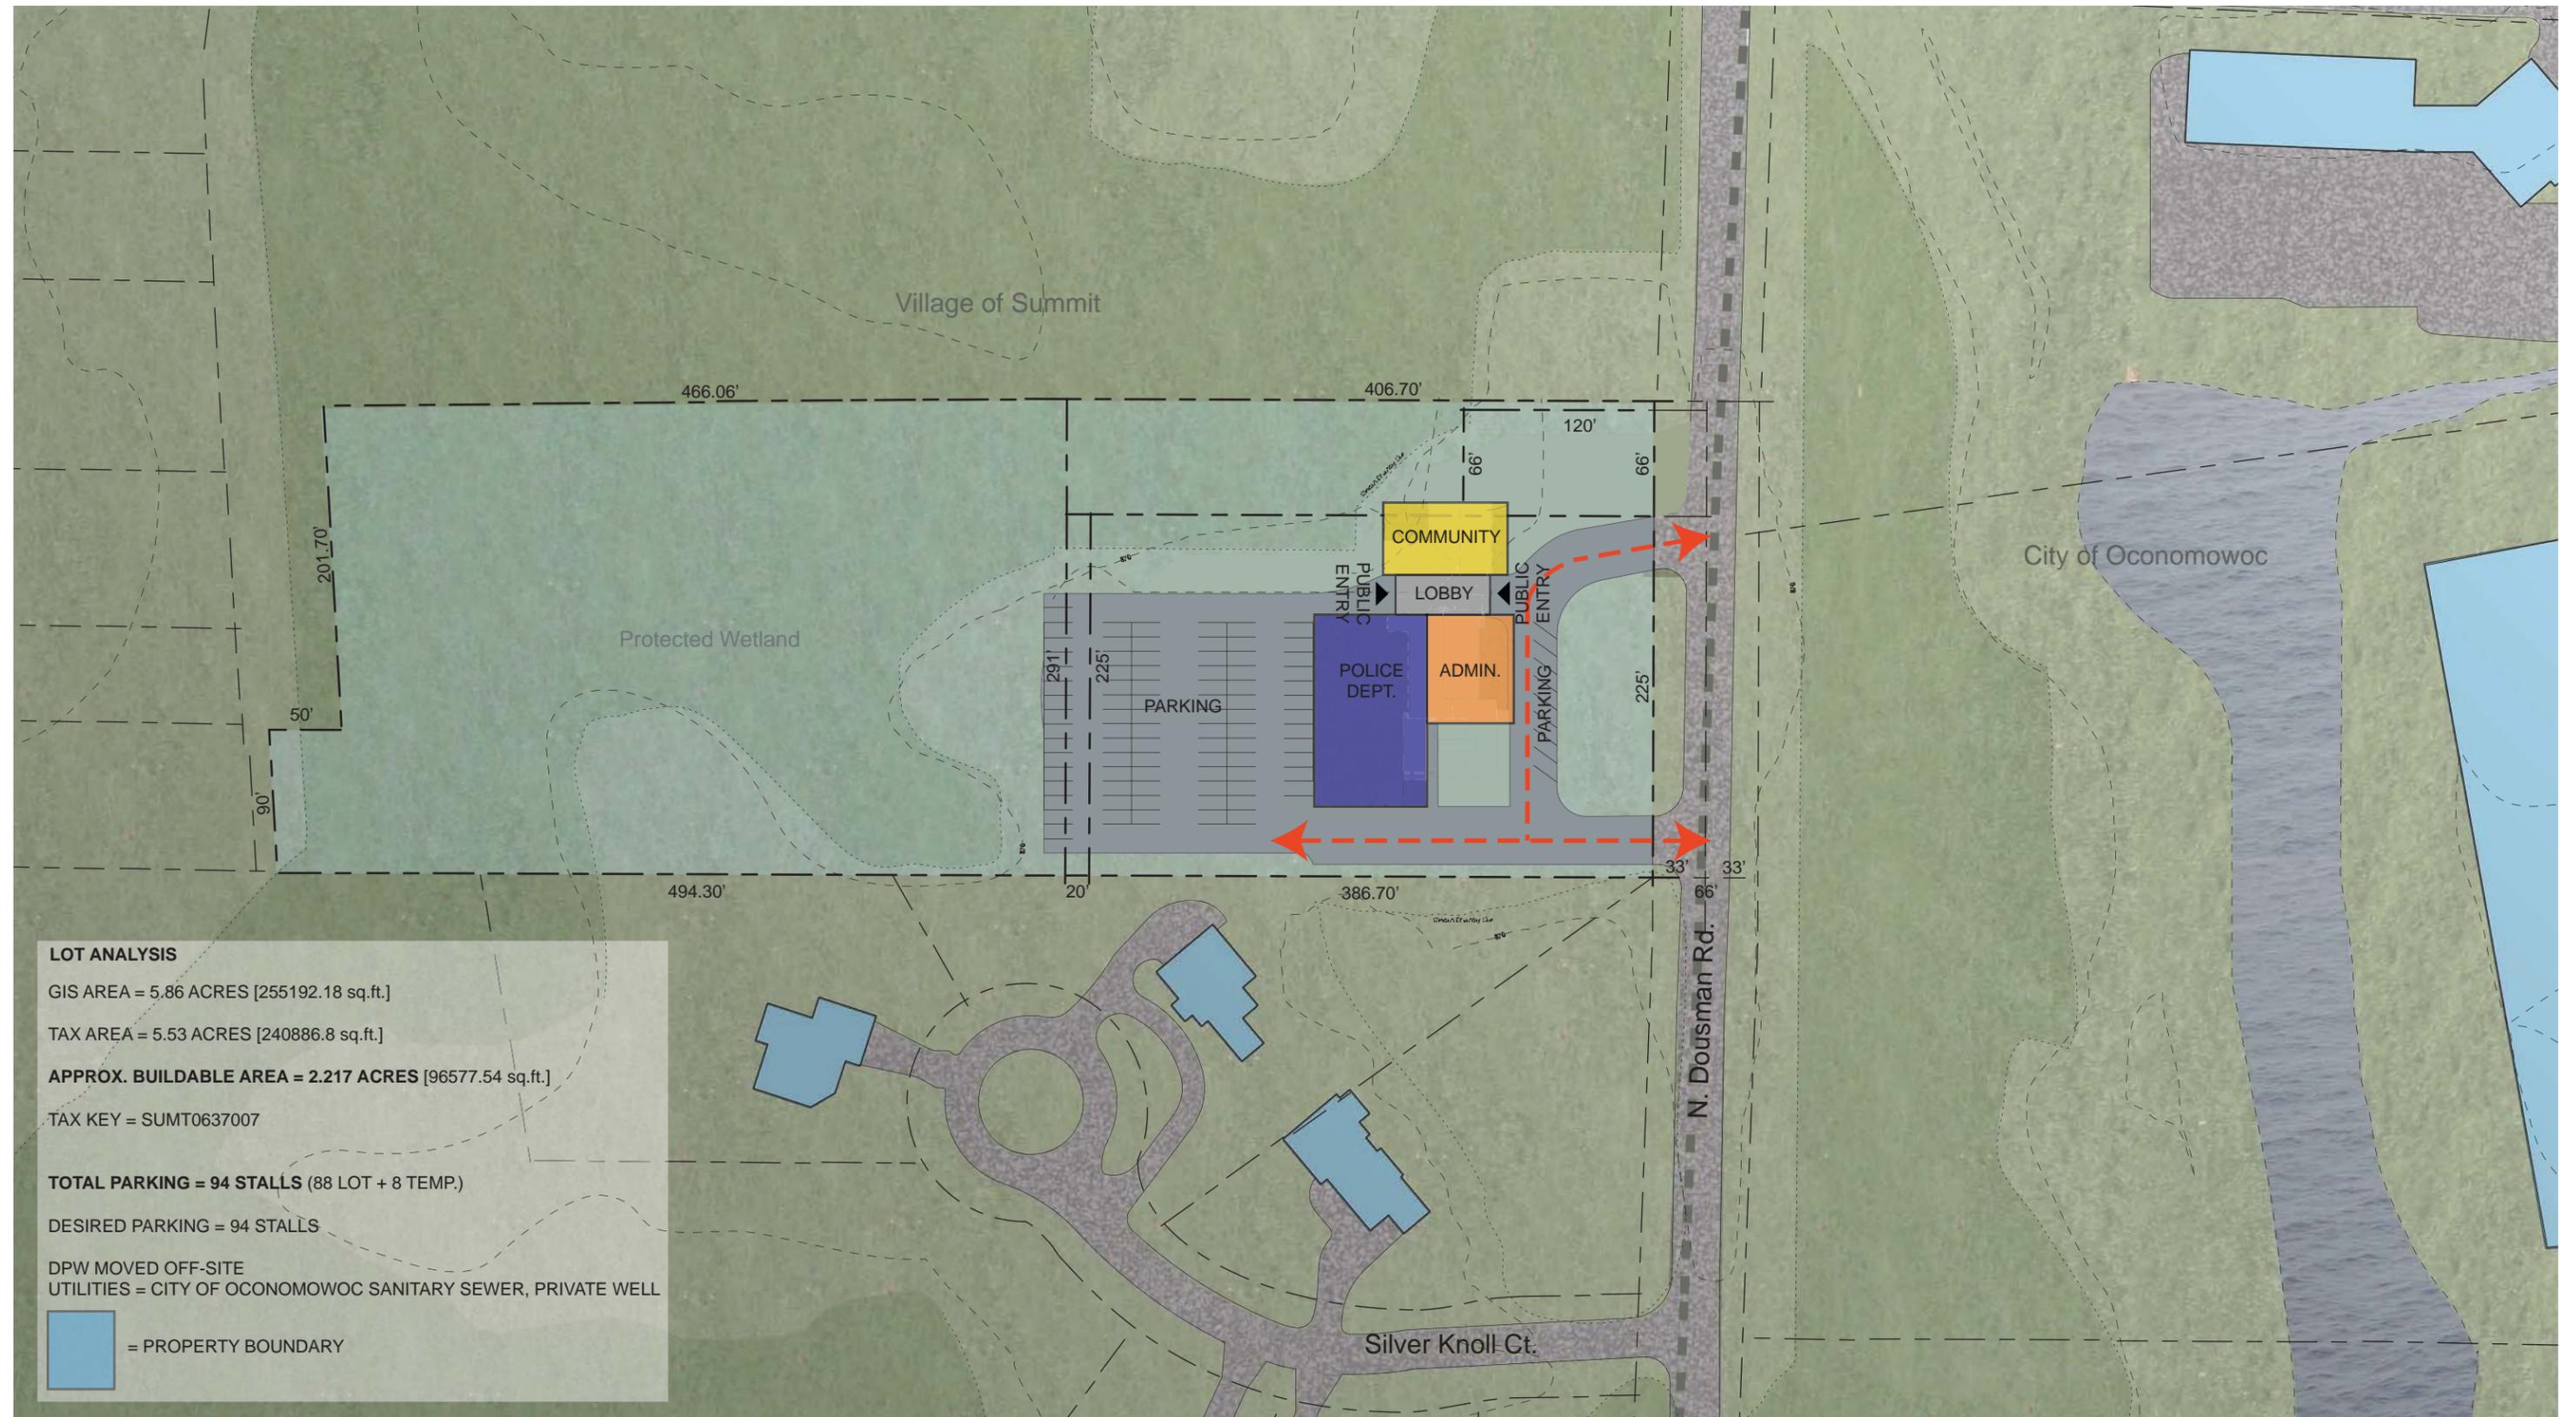
Option 1C:

New Construction - Existing Site | Cost Estimate \$6,757,632 - \$7,468,964

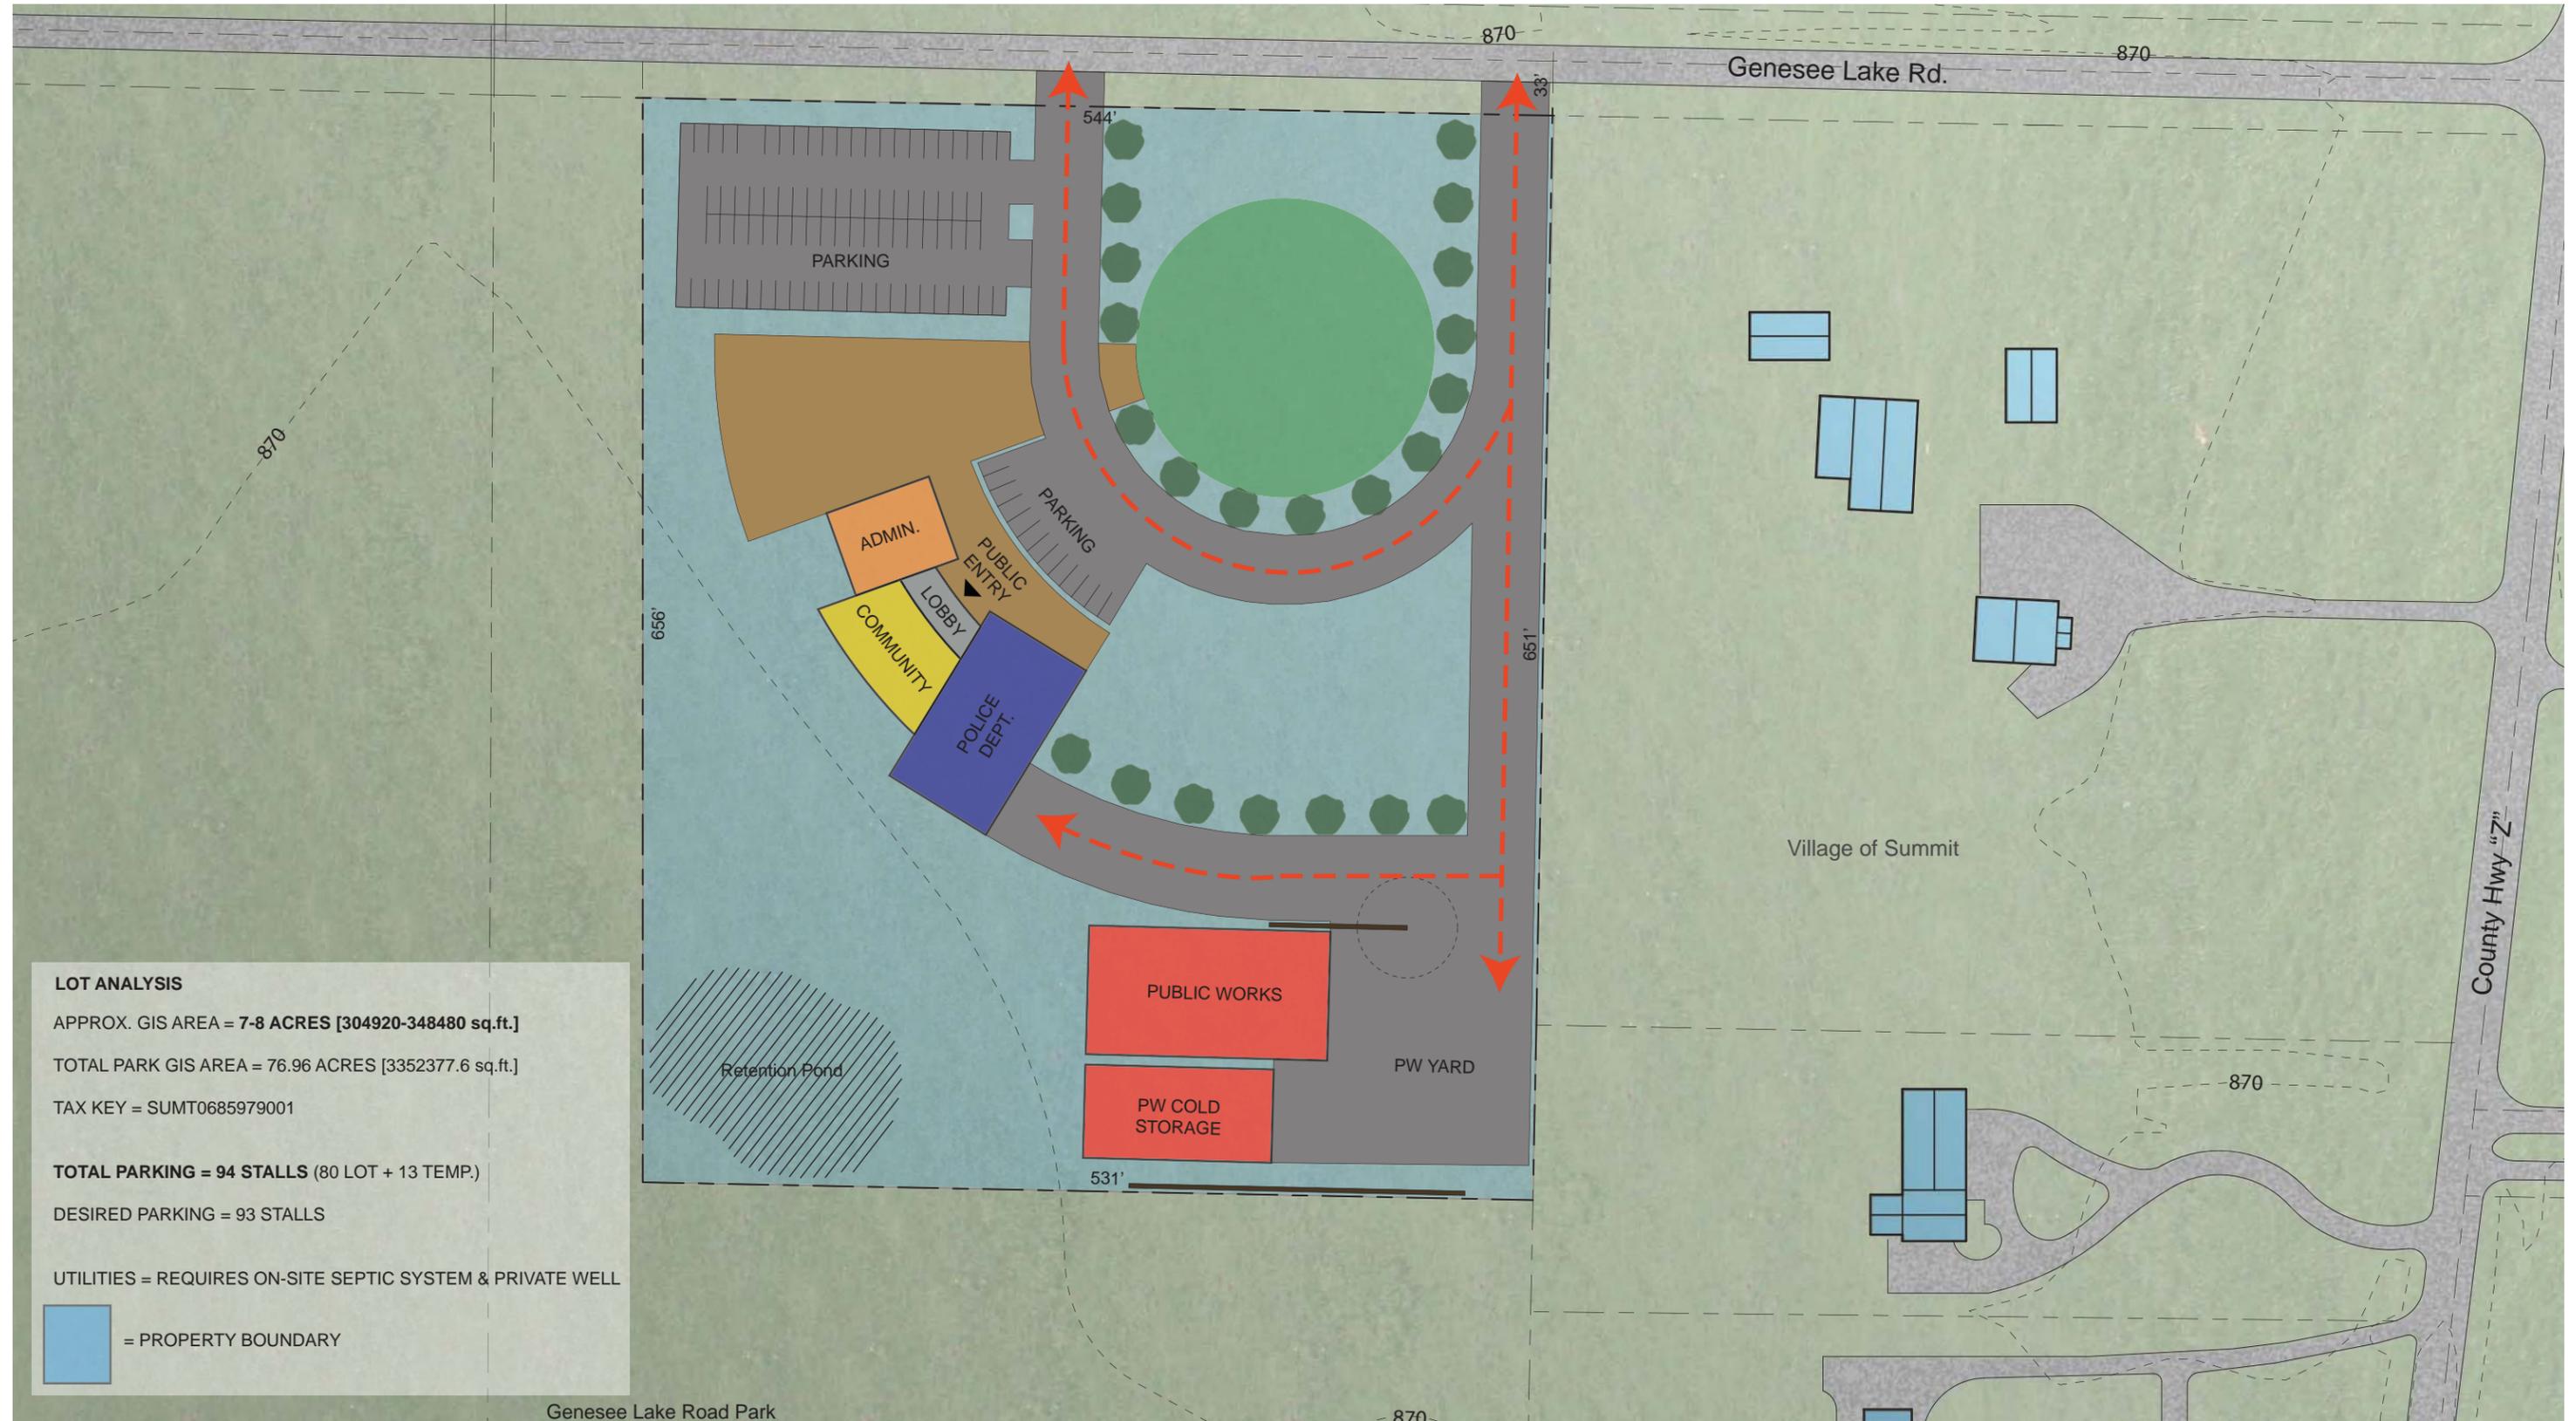
Option 2:

New Construction - Park Site | Cost Estimate \$6,662,585 - \$7,363,912

LOT ANALYSIS
 APPROX. GIS AREA = 7-8 ACRES [304920-348480 sq.ft.]
 TOTAL PARK GIS AREA = 76.96 ACRES [3352377.6 sq.ft.]
 TAX KEY = SUMT0685979001

TOTAL PARKING = 94 STALLS (80 LOT + 13 TEMP.)
 DESIRED PARKING = 93 STALLS

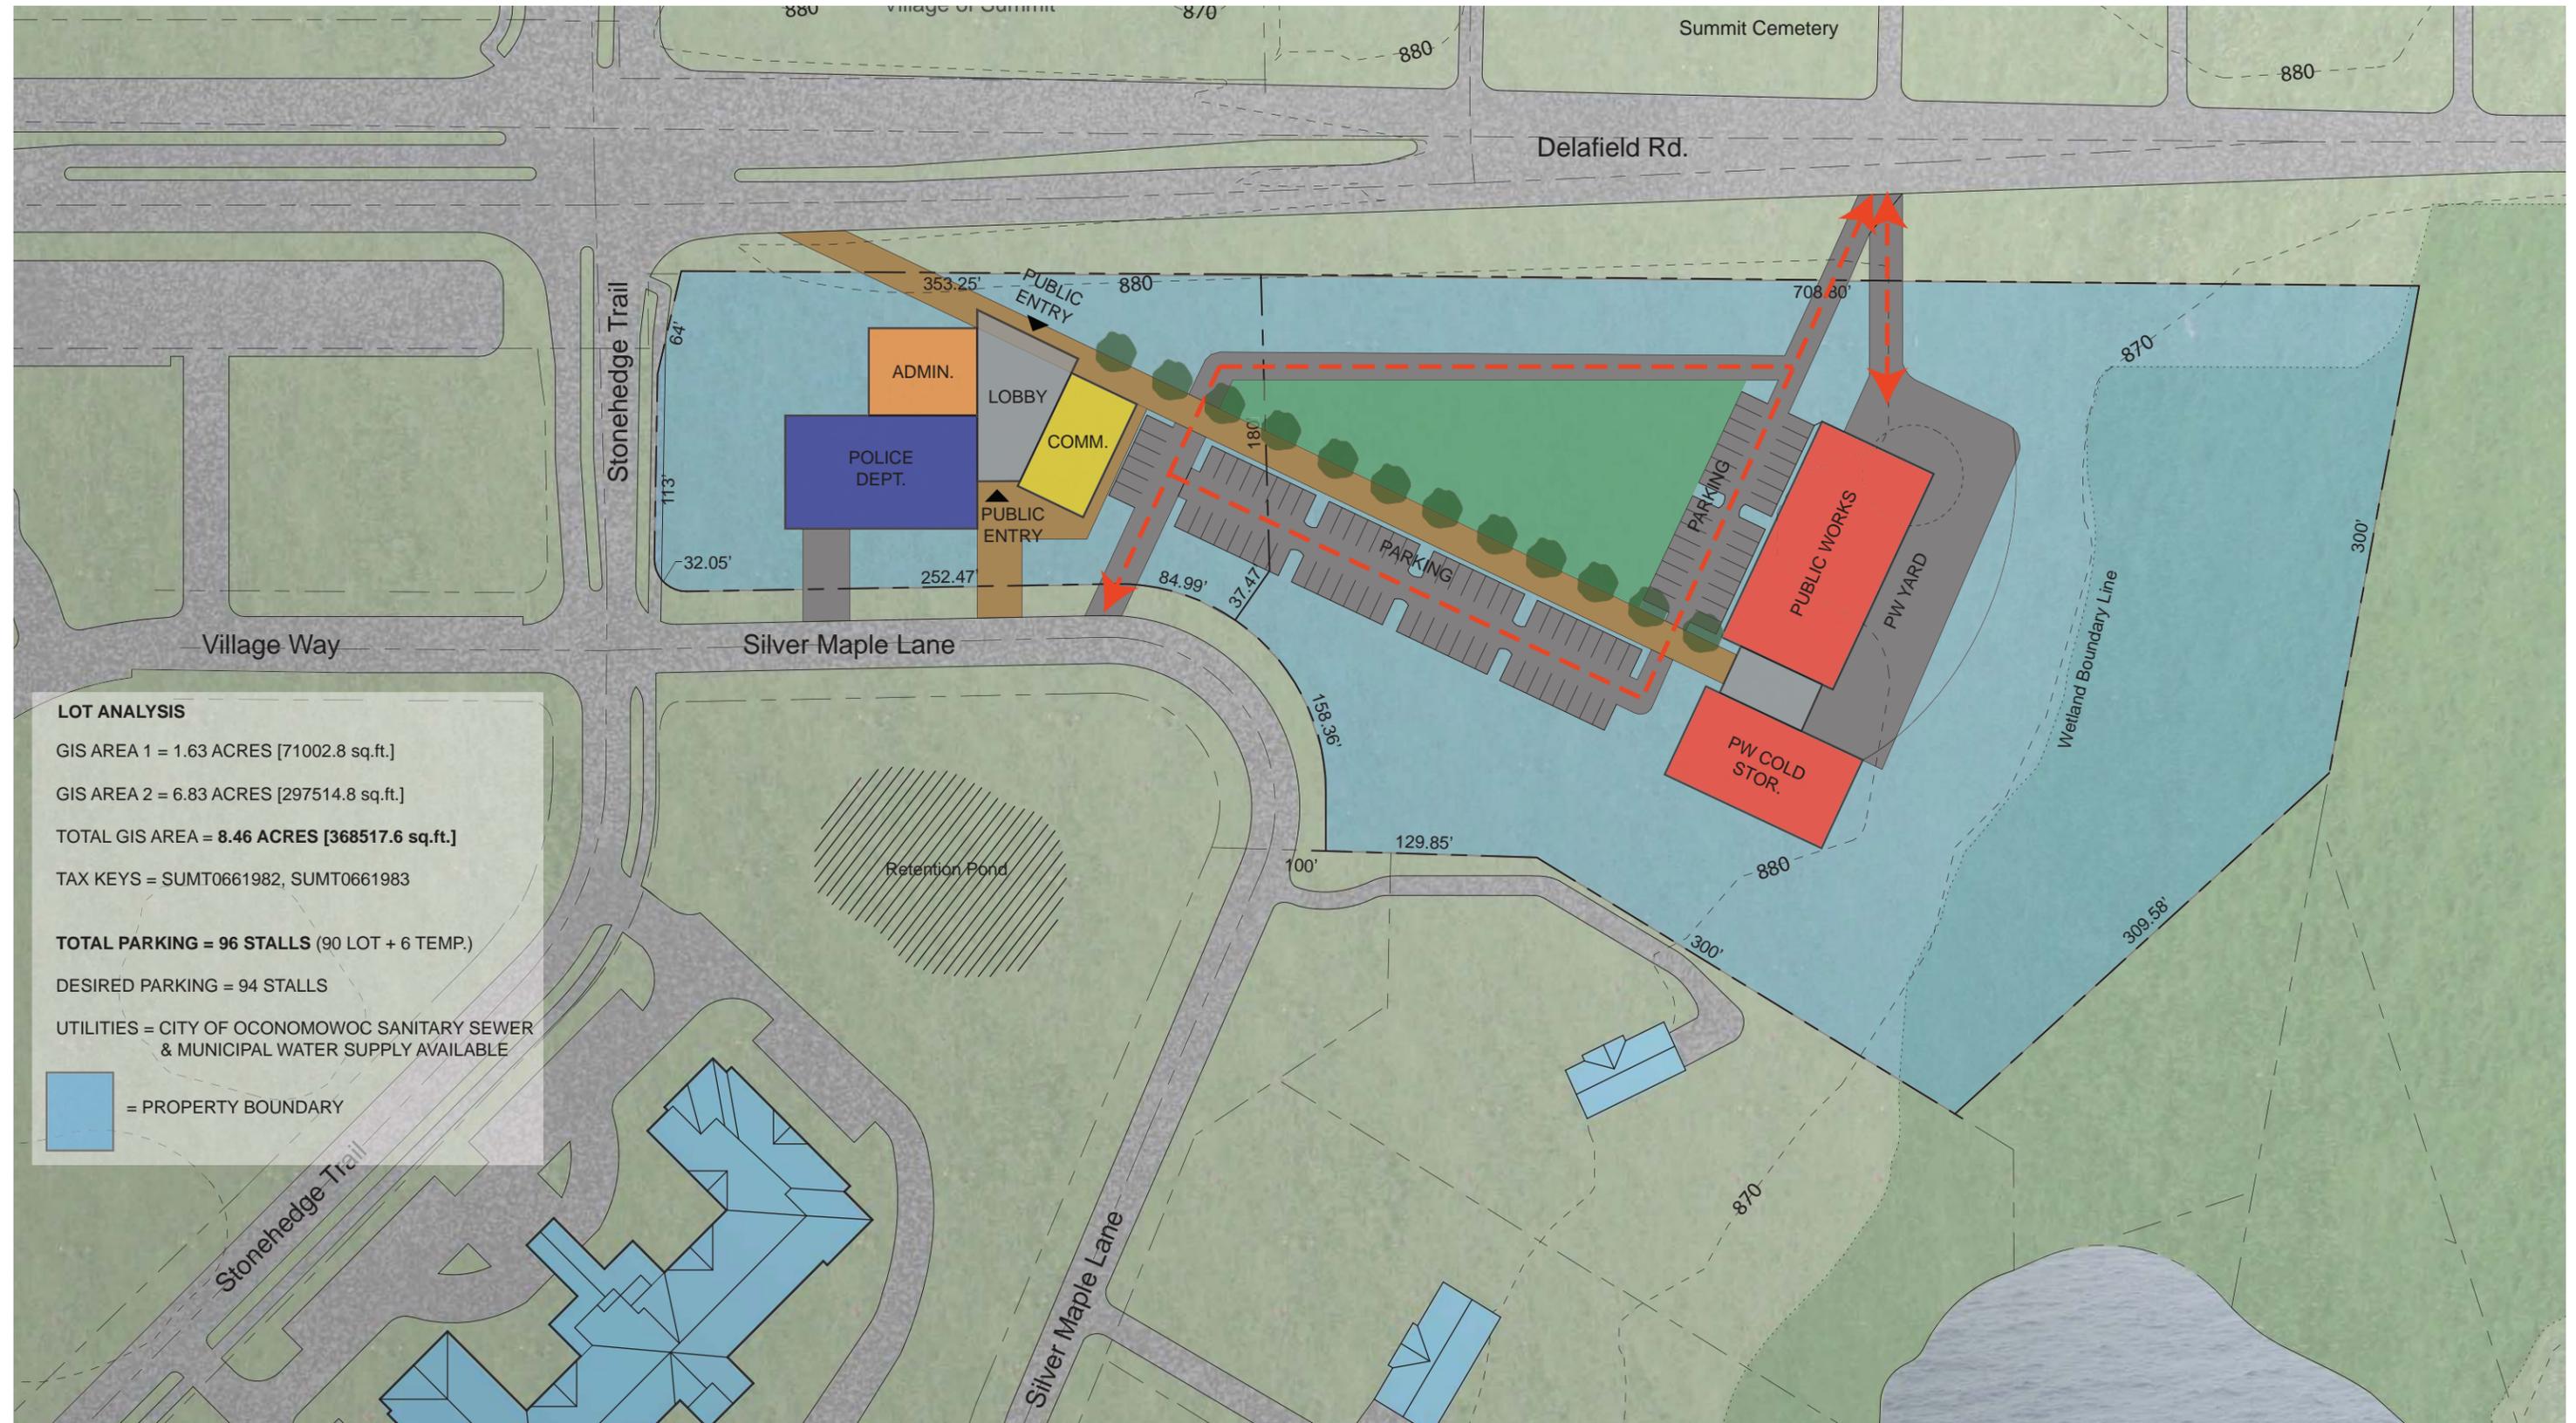
Option 3:

New Construction - Village Commons Site | Cost Estimate \$9,212,204 - \$10,181,912

LOT ANALYSIS

GIS AREA 1 = 1.63 ACRES [71002.8 sq.ft.]
